EXHIBIT # 10

ENVIRONMENTAL OVERVIEW

CITY OF NATCHITOCHES
NATCHITOCHES INDUSTRIAL PARK SITE
LAND GRANTS 71, 72, & 73
NATCHITOCHES PARISH, LOUISIANA
LOCATION MAP

On January 30, 2014, Wayne Kilpatrick with NoLa Soil Services, Inc. conducted a wetland determination and environmental overview of the Natchitoches Industrial Park site. This investigation focused on issues and site conditions pertaining to Listed Endangered or Threatened Species and/or their habitat, areas that may be considered jurisdictional under Section 404 of the Clean Water Act and significant historical/cultural sites. Representative photographs, supporting soil data, vegetative survey and hydrology data were taken and are presented for documentation.

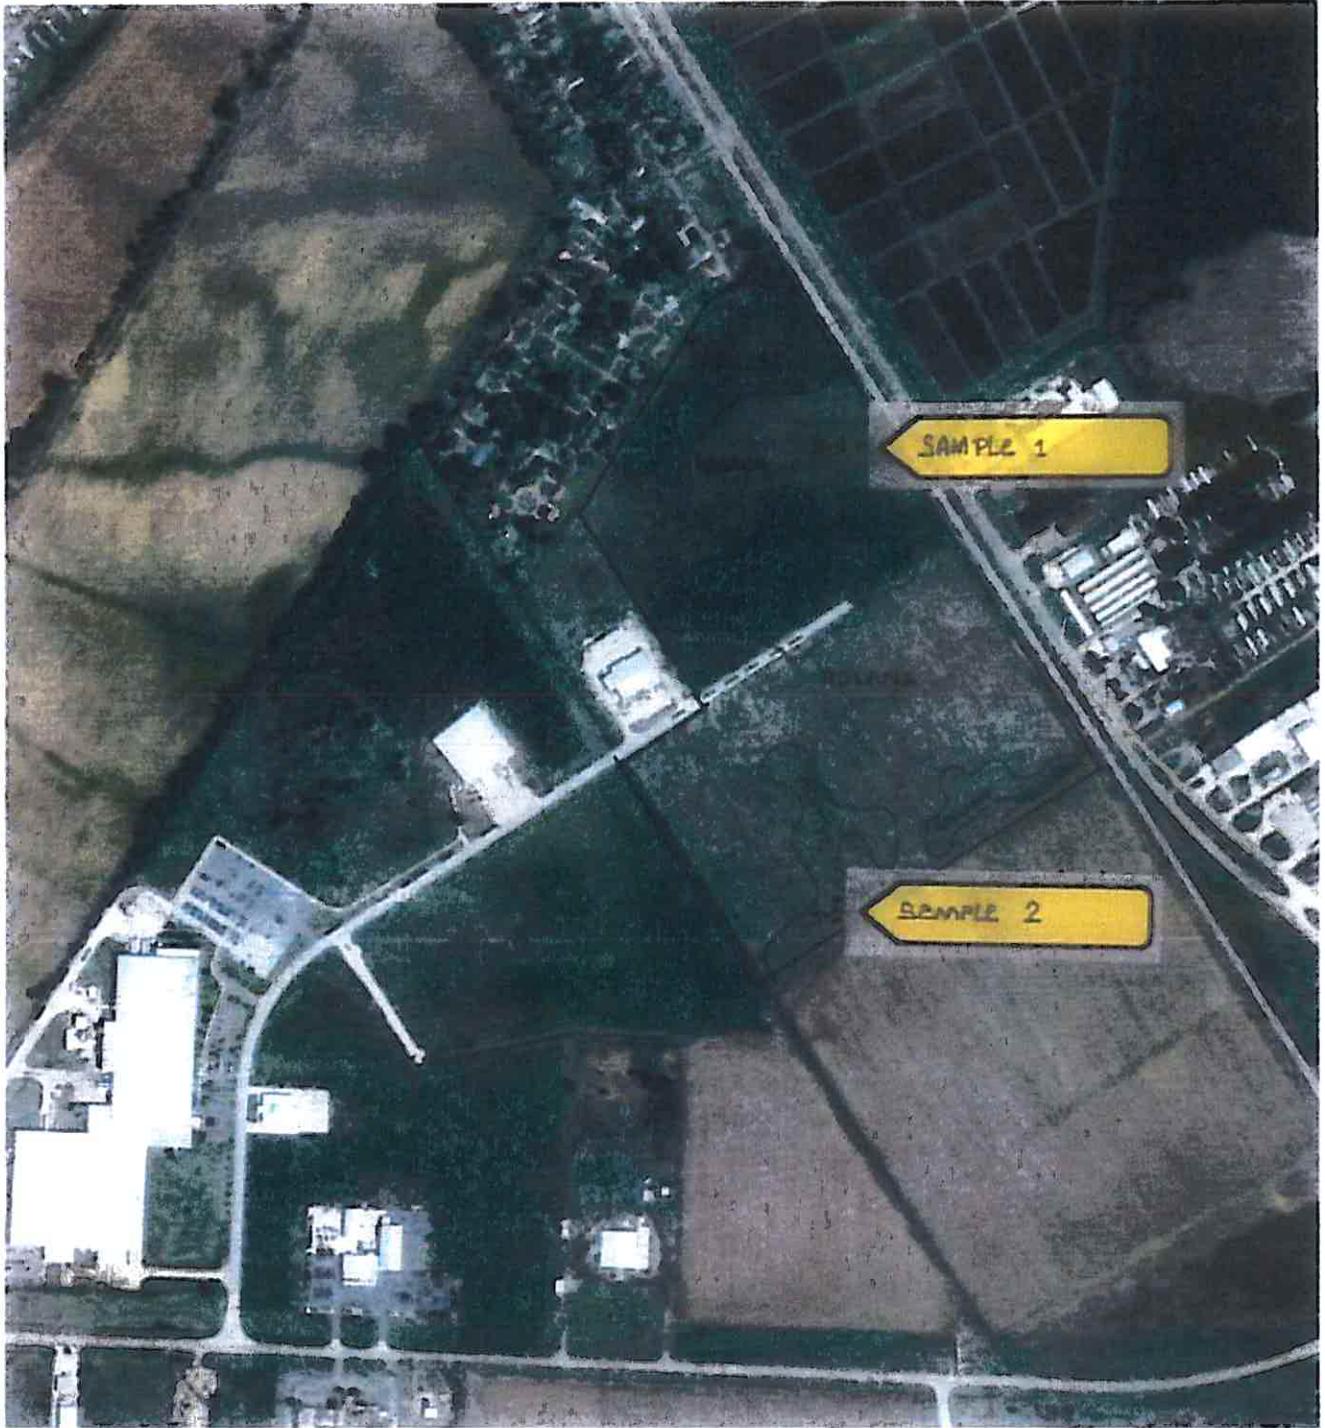
LOCATION FOR VEGETATION, HYDROLOGY AND SOILS DATA MAP

The entire proposed project site was traversed on foot. Several soil borings were taken and vegetation data along with hydrologic conditions were noted and recorded. The Gallion and Roxana soils were observed. Presented are COE Data Sheets for the soils observed on this proposed project.

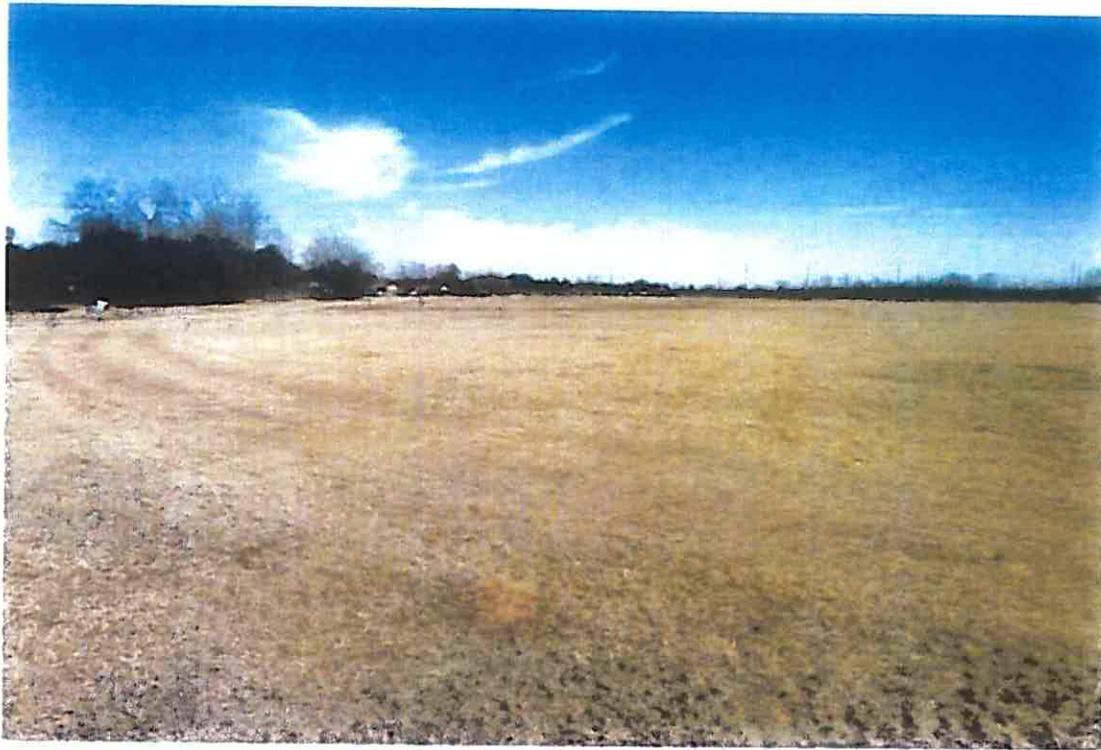
Photograph: 1

Photo Description: This view is in a northward direction along the west side of the proposed project site. The entire parcel of property is presently used for hay production. The landscape is a natural levee and the soils are well drained.

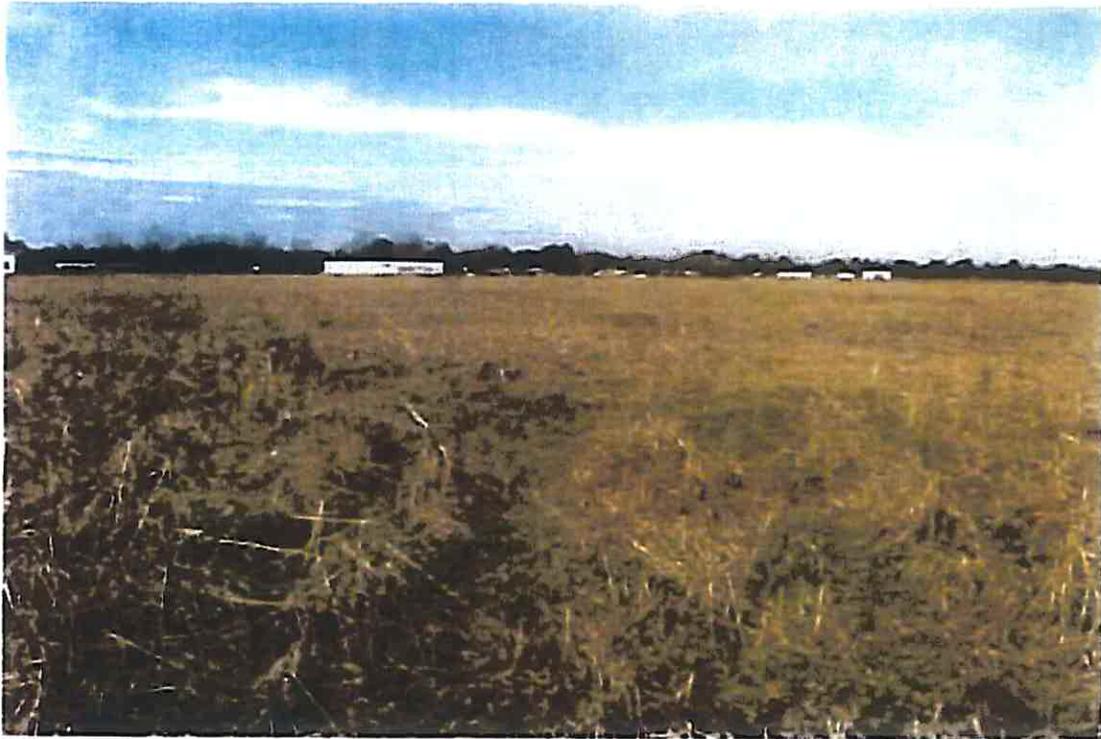
Photograph: 2

Photo Description: A northward view from the southwest corner of the proposed project site. This property has been in agricultural production for several years. It has been precision leveled and land graded for production of row crops such as cotton, corn, and soybeans. The soils are well drained.

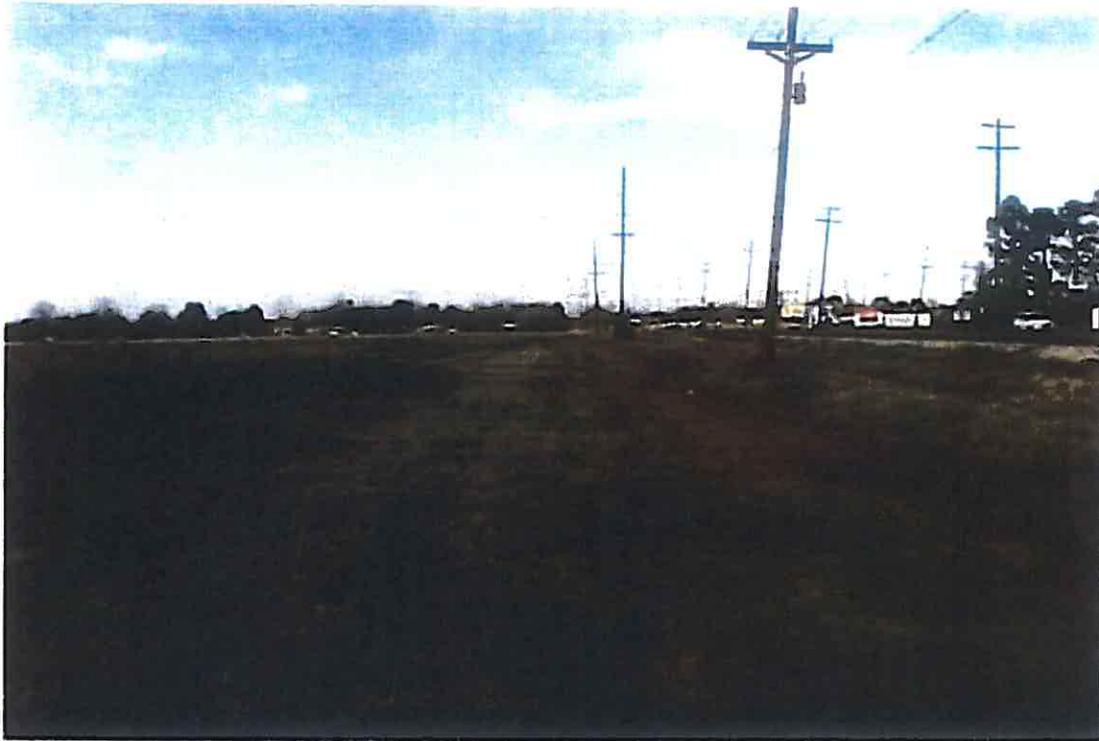
Photograph: 3

Photo Description: Looking northwestward from southeast corner of project site. A railroad and La. Hwy. 1 borders this side of the site. There are no wetlands on the proposed project site.

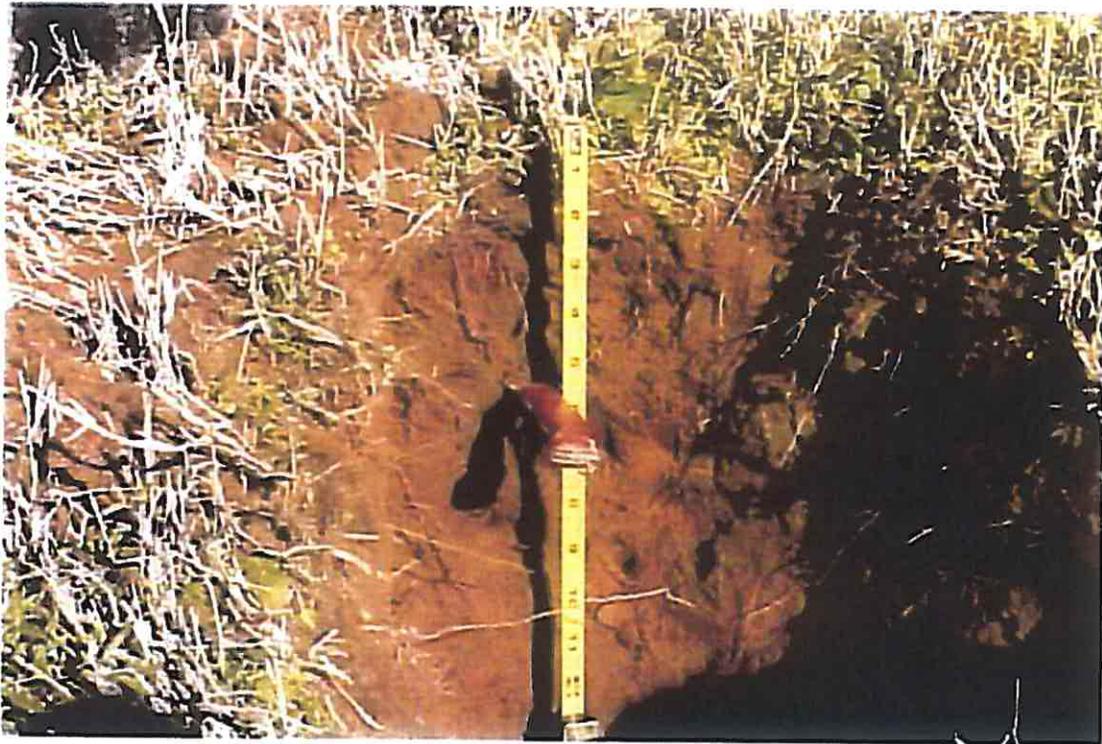
Photograph: 4

Photo Description: This soil profile indicates the soils are loamy and well drained. Only two soil series were found on the project site. These soils are Roxana and Gallion; both are well drained and non-hydric. Wetland criteria is not present on the proposed site.

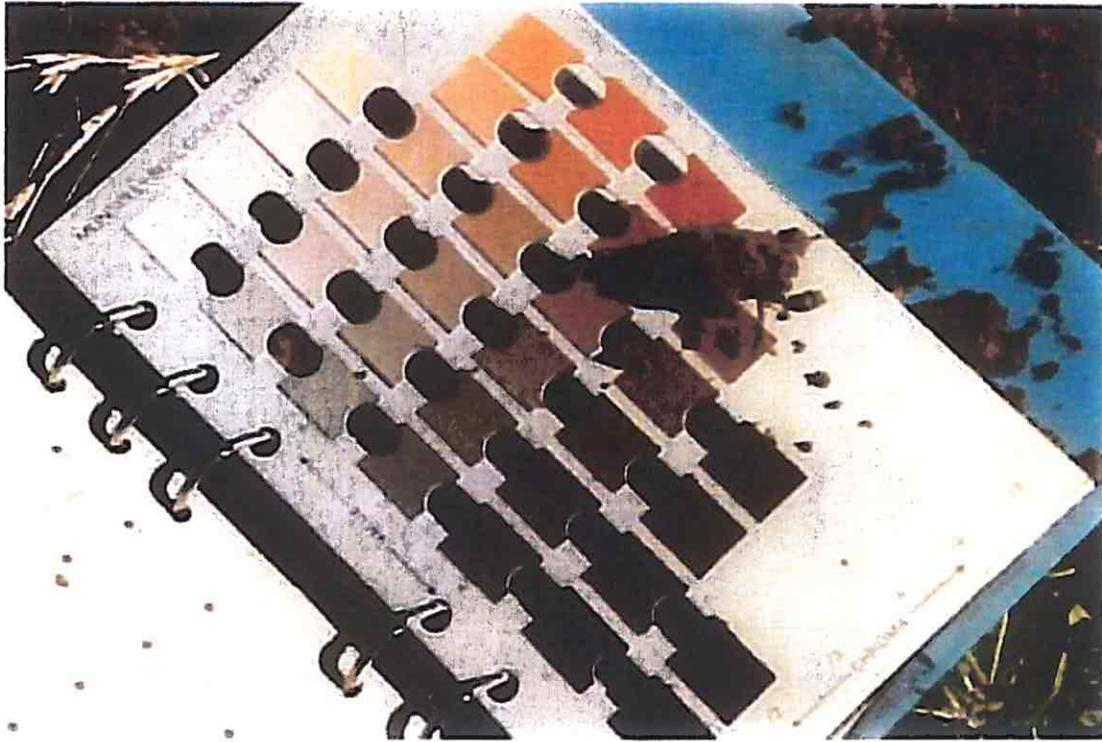
Photograph: 5

Photo Description: The Munsell soil color chart indicates these soils are reddish brown and yellowish red. The soils are classified as Typic Udifluvents and Typic Hapludalfs. The reddish colors indicate these soils are well drained and are non-hydric.
